Department of Civil and Environmental
Engineering, and
Department of Naval Architecture and
Offshore Engineering,
University of California,
Berkeley, CA 94720-1712

Capacities of Template-Type Platforms in the Gulf of Mexico During Hurricane Andrew

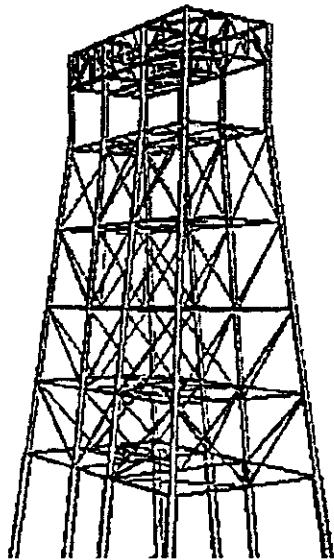
Fig. 1 Platform B

PB is a self-contained, eight-leg, drilling and production platform with twelve well slots and nine drilled wells (Fig. 1). The platform was installed in 118 ft (36 m) of water in the South Timbalier region in 1964. The platform was designed according

Cellar and main deck elevations were located at +34 ft (10 m) and +47 ft (14 m), respectively. The major deck framing is 43 ft (13 m) by 93 ft (28 m) in plan, and the jacket legs are battered at one to eight in both broadside and end-on framing. The deck legs are 36 in. (91 cm) in diameter with a wall thickness of 0.625 in. (1.6 cm) and are connected to the tops of the piles with welded shim connections. The 39-in. (99-cm) dia legs have an average wall thickness of 0.50 in. (1.3 cm) and have no joint cans. However, gusset plates are used with the jacket leg K-joints. The broadside braces vary from 14 in. (36 cm) in the first of four jacket bays to 20 in. (51 cm) in the lowest jacket bay, while the end-on bracing varies from 14 in. (36 cm) to 16 in. (41 cm).

The 36-in. (91-cm) piles extend 190 ft (58 m) below the mudline through 165 ft (50 m) of soft to stiff gray clay and 25 ft (7.6 m) of fine dense sand. PB piles were grouted inside its 39-in. (99-cm) jacket legs in 1973.

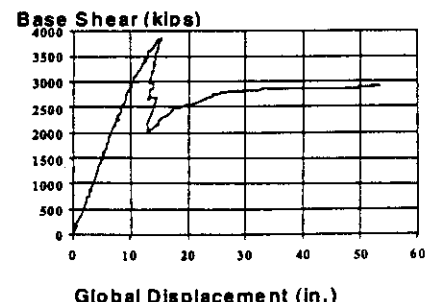
Fig. 2 Platform B broadside loading force-displacement relationship (1 kip = 4.4 kN, 1 in. = 2.5 cm)

Broadside Loading. The force-displacement curve for broadside loading is shown in Fig. 2. This curve indicates that platform fails at 0.907 of the reference load pattern or a total

base shear of 3860 kips (17 MN). This lateral loading capacity is less than the 4900 kips (22 MN) reported by Imm et al. (1993). This difference is due to the differences in the loading patterns utilized in the two analyses. The analyses reported in this paper have larger wave forces acting on the platform lower deck.

Figure 2 indicates that the platform has no reserve strength after the first brace-joint failure. However, it is important to note that the platform can experience large inelastic displacement before a failure mechanism is formed. If the force-displacement curve were extended, it would show that eventually, the jacket legs develop sufficient resistance in bending to cause buckling of the braces in the third jacket bay.

Comparisons of Analytical and Observed Results. The hurricane hindcast data (Cardone and Cox, 1992) and observed platform performance indicate that PB survived 60-ft (18-m) to 64-ft (20-m) waves 15 deg off the broadside during hurricane Andrew. Approximately 96 percent the peak loading developed during the storm was resisted by the broadside framing. The USFOS analysis indicates that the platform experiences first significant member failure, brace-joint failure, at 91 percent of the load from a 64-ft (20-m) direct broadside wave.

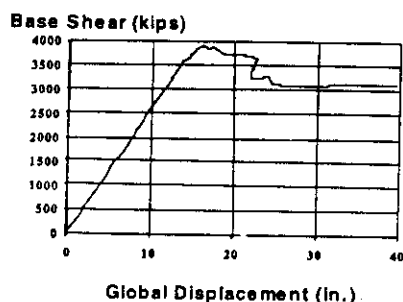
Fig. 3 Platform B end-on loading force-displacement relationship (1 kip = 4.4 kN, 1 in. = 2.5 cm)

End-on Loading. The force-displacement curve for end-on loading is shown in Fig. 3. This curve indicates that the uppermost compression braces buckle at 1.12 of the reference load pattern or a total base shear of 3900 kips (17 MN). Figure 3 shows that after the compression braces-joints in the fourth jacket bay fail, the platform has a small increase in resistance capacity until the compression braces in the third jacket bay and the horizontal framing between these two levels almost simultaneously fail, at which point the platform is at imminent collapse.

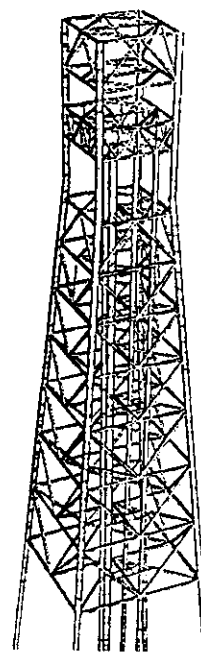
Fig. 4 Platform C

PC (Fig. 4) was installed in the GOM ship shoal region in 1970. This platform is a self-contained four-pile drilling and production platform located in 157 ft (48 m) of water. PC survived hurricane Andrew without significant damage.

The platform has four conductors and eight risers. The PC decks are located at elevations of +33 ft (10 m), +43 ft (13 m), +56 ft (17 m) and +71 ft (22 m). The deck legs form a 30-ft (9-m) by 30-ft (9-m) square plan at the top of the jacket, and the jacket legs are battered at 1:1 in both primary directions.

The piles for PC run through the jacket legs, but unlike PB, the pile-jacket leg annulus is not grouted. The 36-in- (91-cm-) dia piles extend 355 ft (108 m) below the mudline through 328 ft (100 m) of soft to stiff gray clay and 27 ft (8 m) of fine dense sand. The sand layer starts at 197 ft (60 m) below mudline. The clay above the sand is generally soft and silty, while the clay below the sand is stiff.

While the pile-leg annulus is not grouted, the jacket legs and most other intersecting members have joint cans. The 39.5-in- (100-cm-) dia jacket legs are 0.5 in. (1.3 cm) thick, while the joint cans are 1.25 in. (3.2 cm) thick. The deck legs are 36 in. (91 cm) in diameter with a wall thickness of 1.25 in. (3.2 cm) and are connected to the tops of the piles. The vertical braces vary from 16 in. (41 cm) in the top jacket bay to 20 in. (51 cm) in the bottom jacket bay. All members reportedly are constructed of nominal 36 ksi (248 MPa) steel with an average yield stress of 43 ksi (297 MPa).

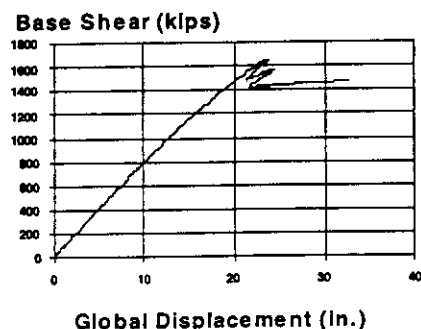
Fig. 5 Platform C force-displacement relationship based on static pile capacities (1 kip = 4.4 kN, 1 in. = 2.5 cm)

Loading Results. The initiating failure mode for PC based on the static pile characterization was pile plunging. The force-displacement history for broadside loading is shown in Fig. 5. This curve indicates that platform fails at 0.628 of the reference load pattern or a total base shear of 1700 kips (7.6 MN) at a displacement of about 24 in. (61 cm). From Fig. 5 it can be seen that the platform has a constant stiffness after all the T-Z and Q-Z springs of the compression piles have reached their final plateaus.

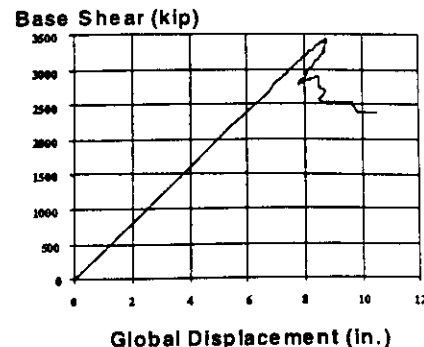
Fig. 6 Platform C force-displacement relationship based on dynamic pile capacities (1 kip = 4.4 kN, 1 in. = 2.5 cm)

Results from the USFOS analyses showed that if the foundation was characterized based on consideration of dynamic effects, the braces in the second jacket bay became the weak link. The second bay compression braces buckled at 1.30 of the reference load pattern or a total base shear of 3440 kips (15 MN). After the compression braces in the second jacket bay buckled, the braces in the third jacket bay buckled and the jacket began to "unzip."

The lateral force-displacement characteristics for the analyses based on the dynamic pile characterization is given in Fig. 6. The peak lateral load capacity is 3500 kips (16 MN) and it is reached at a lateral displacement of about 9 in. (23 cm). Based on the dynamic pile characterization, the lateral load capacity of the platform is about doubled.

Comparison of Analytical and Observed Results. The hurricane hindcast data (Cardone and Cox, 1992) and observed platform performance indicate that PC survived 53 ft (16 m) to 56 ft (17 m) waves during hurricane Andrew. Based on the results from the analyses performed on PC, the total lateral loading associated with these conditions ranged from 1700 kips (7.6 MN) to 1900 kips (8.4 MN). These loadings exceed the platform capacity that was based on static pile capacities. However, they do not exceed the platform capacity that was based on dynamic pile capacities. Given that the platform survived hurricane Andrew without significant damage, it is concluded that the platform capacity based on the dynamic pile simulations is more realistic.

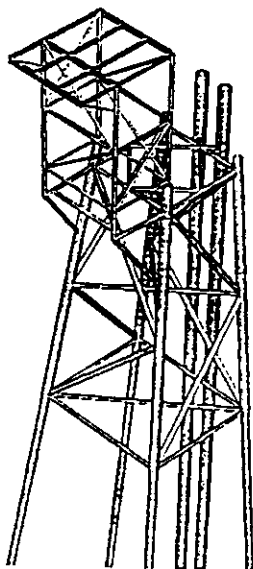
Fig. 7 Wellhead protector 1

The eye of hurricane Andrew passed within a few miles to the west of wellhead protectors 1 (WP1) and 2 (WP2) (Figs. 7 and 8). Hurricane Andrew produced extreme storm loadings which caused WP1 to collapse. Diver surveys made after the storm indicated WP1 failed by pull-out of the piles on the south side of the platform. The seemingly identical WP2 did not collapse; there was no significant damage to this structure. The goal of this study was to determine how the forces developed by hurricane Andrew could have caused the collapse of WP1 and not the collapse of WP2.

WP1 and WP2 were both located in the South Timbalier area. The two wellhead protectors were designed and installed early in the 1980s by the same firm. The two wellhead protectors were designed according to the same API RP 2A guideline. The slightly older WP1 was located in 52 ft (16 m) of water. The primary horizontal axis of WP1 was oriented at 315 deg (from true north). WP2 is located in 49 ft (15 m) water about 1500 ft (457 m) to the northeast of WP1. WP2 is oriented with its primary horizontal axis parallel to true north. Both structures were two-bay, four-pile template structures designed to provide limited facilities for 36-in. (91-cm-) dia caisson well risers (Figs. 7 and 8). Both protectors had offset braced helipads and boat landings.

The jacket framing of the two structures was almost identical. WP2 had slightly smaller diameter jacket legs and piles; 28 in. (71 cm) and 24 in. (61 cm), respectively. WP1 had 30-in. (76-cm-) and 26-in. (66-cm-) dia jacket legs and piles, respectively. Diagonal vertical bracing was made up of 18-in. (46-cm) tubulars, while plan bracing was composed of 12.75-in. (33-cm) tubulars on all three levels. All members were fabricated using A36 grade steel.

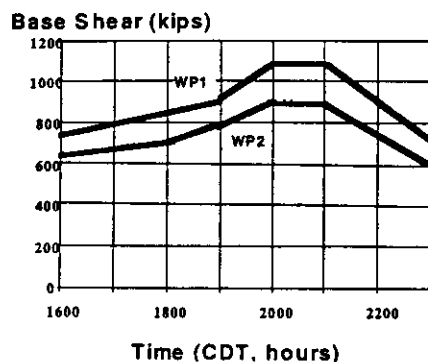
Fig. 9 Time history of base shears on WP 1 and WP 2 during hurricane Andrew (1 kip = 4.4 kN)

Wave loads for USFOS were generated using WAJAC (Det Norske Veritas, 1993). The global base shears developed on WP1 and WP2 during the passage of Andrew are summarized in Fig. 9. The results indicate WP1 experienced peak lateral loadings that were about 20 percent larger than those on WP2.

The peak lateral loading on WP1 was 1100 kips, and on WP2 was 850 kips.

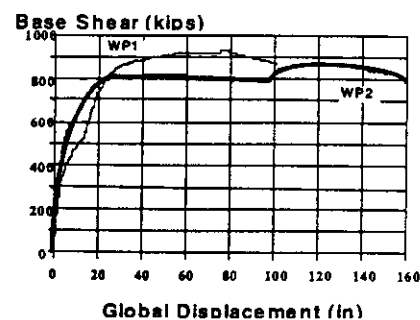
Fig. 10 Load-displacement relationships for WP 1 and WP 2 (1 kip = 4.4 kN, 1 in. = 2.5 cm)

Pushover Results. The static pushover results for WP1 and WP2 based on the USFOS results are summarized in Fig. 10. The "double hump" found in both analyses result from the increased stiffness of the structures when contact between the jacket and caissons occur. The negative stiffness found at the end of all analyses represents pile pullout. The large lateral deformations produced plastic hinges in the piles which produced a near mechanism. It was the additional strength and rigidity of the caissons which prevented the structures from forming a mechanism at this point. The added stiffness of the well caissons allowed the full axial capacity of the soils to be exceeded to produce pile pullout. The maximum lateral load capacity of WP1 and WP2 was found to be 910 kips (4.0 MN) and 880 kips (3.9 MN), respectively.

The USFOS result that both structures fail due to pile yielding and pullout was confirmed by results from the StruCad*3D and ULSLEA analyses. The ratio of the peak lateral loading during hurricane Andrew to the maximum lateral loading capacity was 1.2 and 0.95 for WP1 and WP2, respectively. The analyses indicated that WP1 should have failed due to pile pullout and WP2 should have survived. The paradox of why these two seemingly identical structures behaved differently was due to the differences in the appurtenances (well conductors), the manner in which the caissons were tied into the structures, and the capacities of the underdriven piles. The effects of these differences only became evident when these "details" were determined and their implications integrated into the analyses.
